MT OWEN LOW WALL FAILURE

Bakalářská práce

Hana Šantrůčková

Praha, červenec 2006

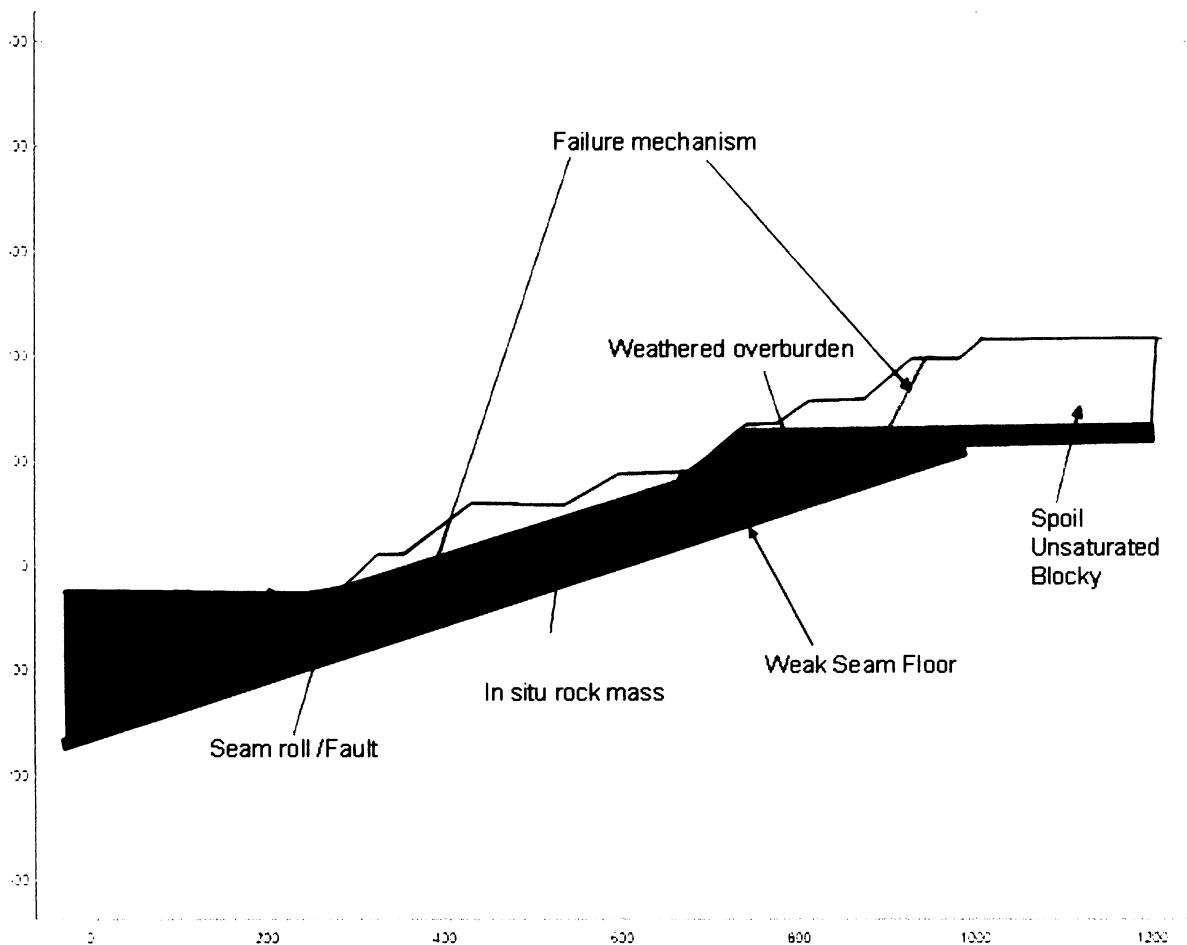
Figure 5: B4 Slope profile

- *Spoil Unsaturated Blocky*: The majority of the dumping spoil material consists of sandstones and siltstones.
- *In situ rock mass*: Consolidated siltstones and sandstones.
- *Seam roll/Fault*: The fault that causes a seam roll.
- *Weak Seam Floor*: Represents weak horizons somewhere within Lower Hebden coal seam or its surrounding, located 20 m below the slope surface. Weak clay horizons were found in this area and hence, it was assumed that partly sheared clay bands made the slip plane.
- *Weathered overburden*: Former surface lies at 125 meters above the reference level (RL). Rock material from 125 metres above RL down to 110 metres above RL has “weaker” material properties due to weathering. Majority of the weathered rock are siltstones and sandstones.

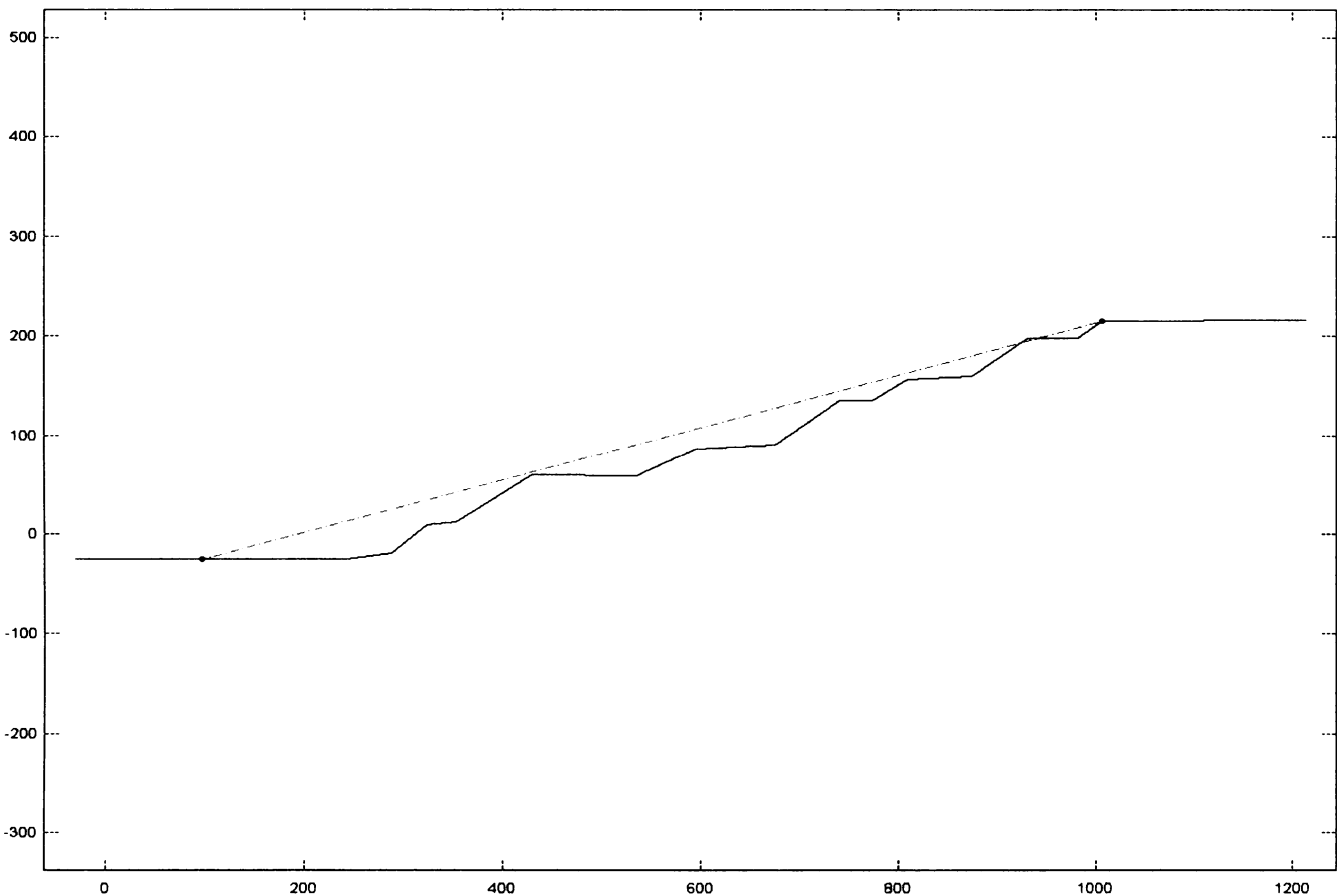
The B4 block is a low wall block with claystones and siltstones as its overburden. It was dumped at an overall angle of 15° (Figure 6). Interwall angles range from approximately 30° to 40°. Benches are close to horizontal and vary in their lengths.

Figure 6: Overall angle of 15° (green dashed line), Interwall angles from the top: 37°, 35°, 31°, 35°, 25°, 32°, 41°.

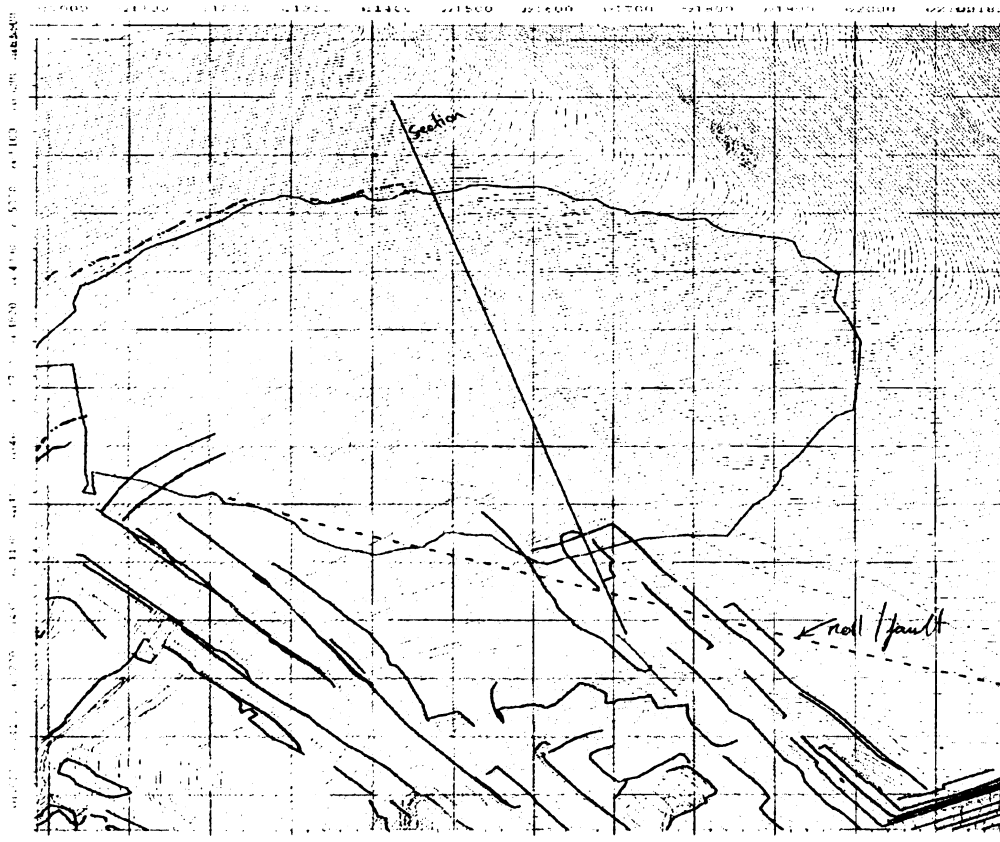
- **Fault:** North-westerly trending fault intersects the B4 block in its southern part (Figure 7). It dips towards the north-west at an angle of approximately 25 degrees and causes a seam roll. The fault comes up to the surface at a point where a low wall face meets with a pit floor.
- **Dyke:** A dolerite dyke is situated in the west flank of B4 block. It's 0.6 – 0.7m thick and is slightly weathered. It dips north-easterly at an angle of 80 degrees.

Figure 7: Fault (dashed line) and the potential B4 failure (contoured line)

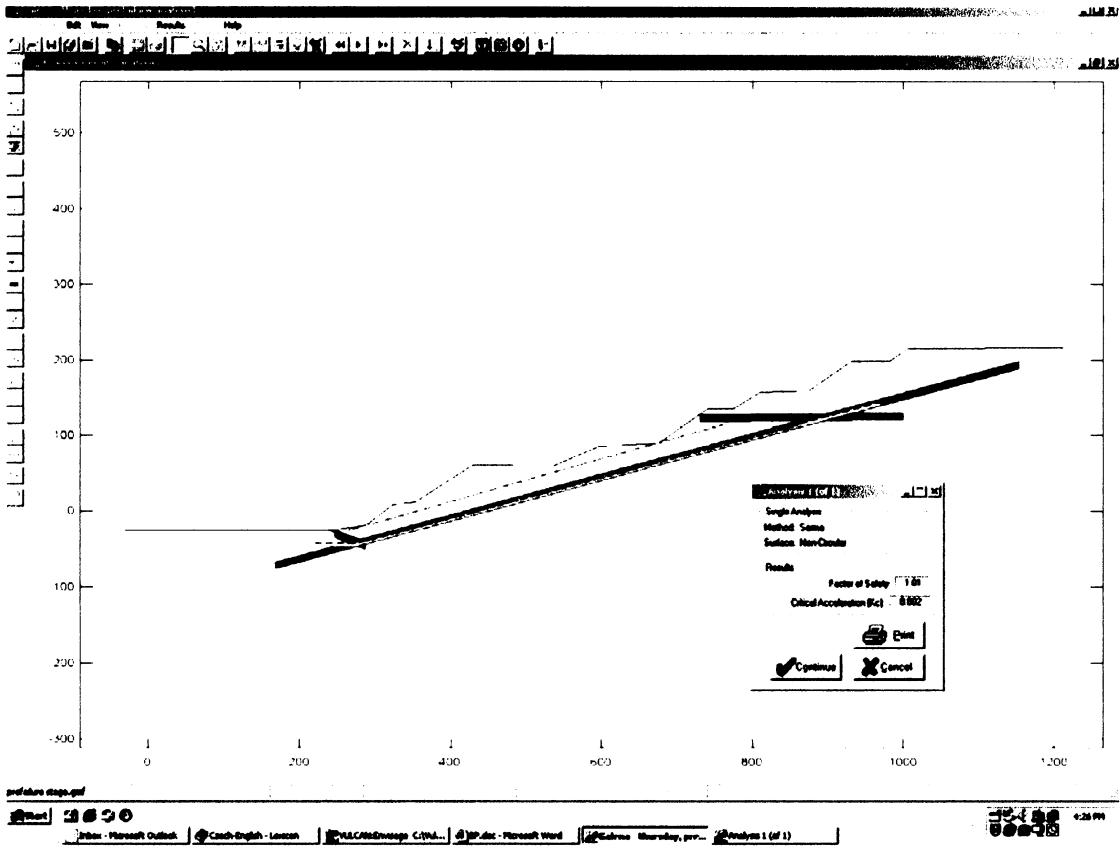
Pre-failure stability analysis was done using strength properties listed in Table 1 and setting the water level to 1 meter above a slip surface. Running the stability analysis with Sarma Non-Vertical Slice Single Method calculated Factor of safety (FS) was 1.01 (Figure 8). This result was satisfactory because the tension cracks implied that the failure is imminent and so the FS close to one. This calculation was done without considering underground water flow or any other kind of disturbance and hence FS 1.01 had to be considered as the highest possibility.

Figure 8: Pre-failure stability analysis plotted in Galena

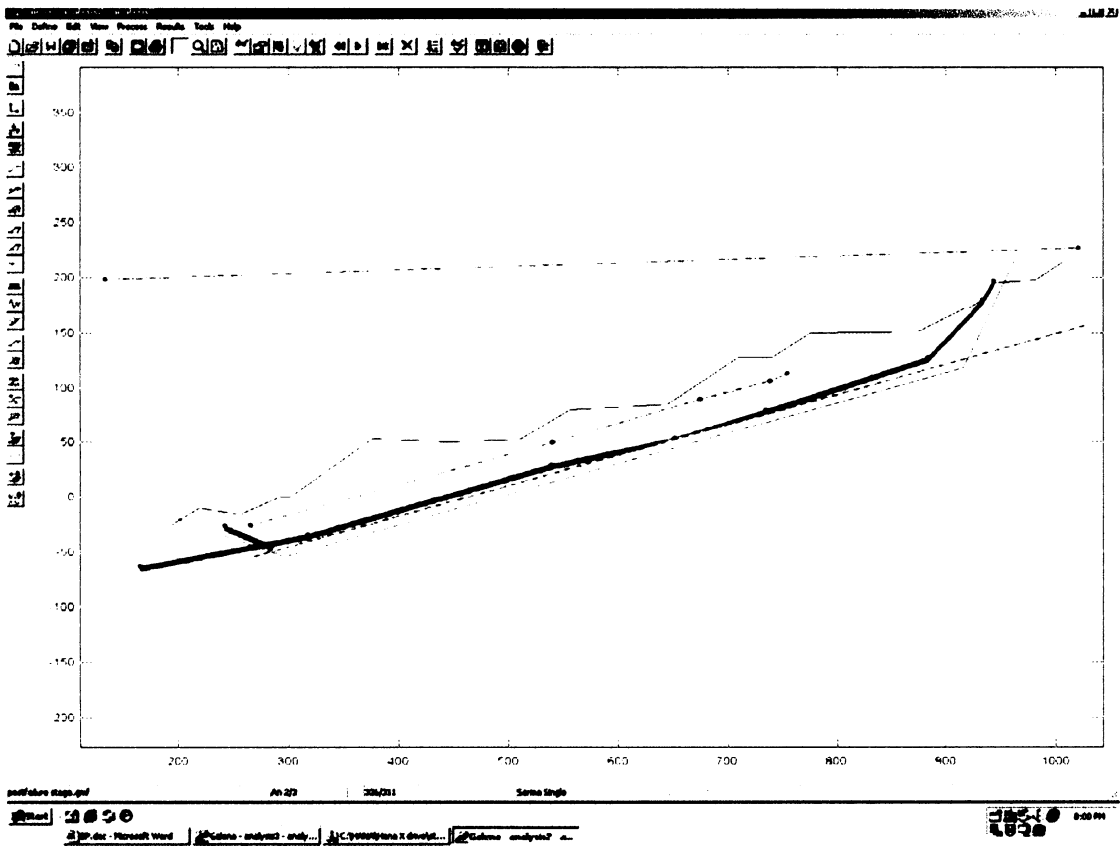
After the failure occurred, slope geometry (Figure 9) was changed and strength of the slip surface decreased to residual strength. Running Sharma Non-Vertical Slice Single analysis, FS 1.11 was received.

Figure 9: Post-failure stability analysis plotted in Galena

As can be seen from the post failure analysis, slipped area couldn't be considered as stabilised even after it failed to its post-failure position. The aim was to build up the FS up to 1.2. The difficult part was in making the slope stable and not burying too much coal while doing that. At Mt Owen it was even harder due to the position into which the failure slipped. The failed overburden buried part of the Upper Hebden seam which was to be mined. That made the remedial work even more complicated because there had to be thought of further geotechnical issues in mining forward.
