Preliminary Report on Excavations at Burgut Kurgan in 2016

The paper summarises the results of the second season of exploration of the Yaz I walled settlement of Burgut Kurgan, south Uzbekistan. The 2016 excavations concentrated on the further investigation of the stone wall and on bringing to light one entire settlement unit.

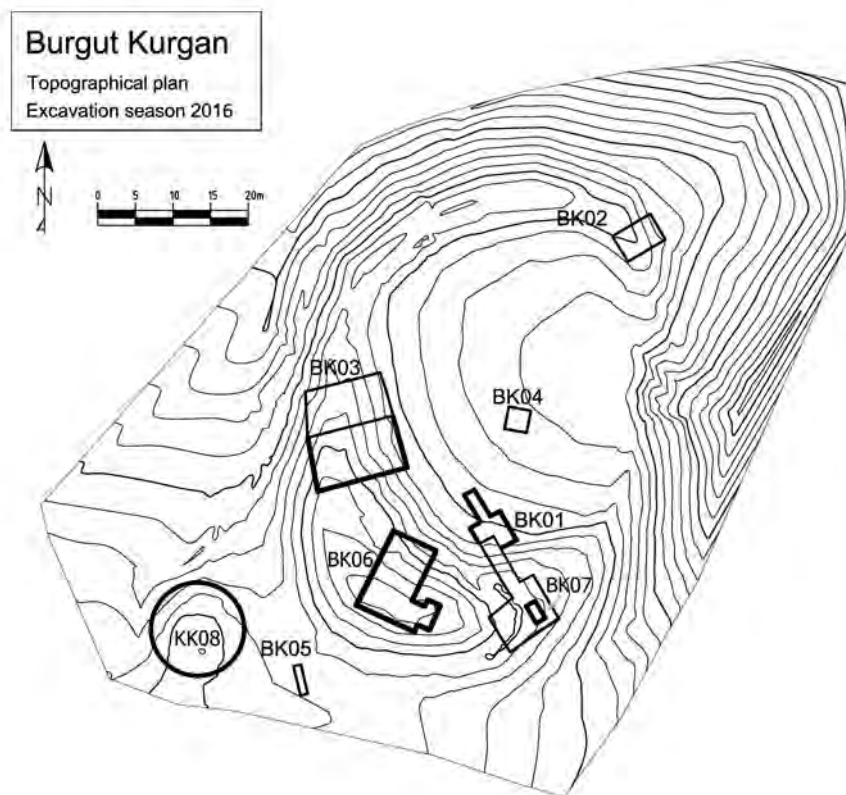
Fig. 1: Burgut Kurgan. Topographical plan and outlines of trenches excavated in 2015 (thin line) and 2016 (bold line).

As a result, this year's excavation (**Fig. 1**) ran in four trenches (BK01, BK03, BK06 and BK07). Moreover, throughout the season we excavated also the kurgan-like structure KKO8 in the immediate vicinity of Burgut Kurgan. This report focuses only on the work in trenches BK01, BK06 and BK07, and their results, while the trench BK03, as well as the excavations of KKO8, will be dealt with separately in near future.

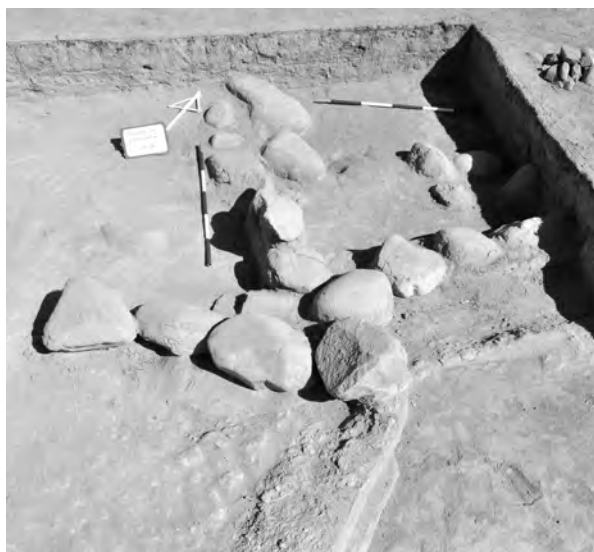
Fig. 2: BK01 - intersection of constructions BK2016_01_037, BK2016_01_038 and BK2016_01_040. Photo J. Kysela.

At the very foothill a series of constructions intersect: a line of large pebbles (20–30 cm), apparently in a mudbrick bed, skirts the foothill in a SW–NE direction (BK2016_01_037 and BK2016_01_040) with two walls perpendicular to it: a very similar line of boulders to the north-west and a narrow mudbrick wall connecting it with the slope (BK2016_01_038). We had no ambition to interpret any of these constructions and their mutual relation due to the limited extent of the trench. Moreover, the layers delimited by these constructions (BK2016_01_039 in the southern corner, BK2016_01_043 in the north-west and BK2016_01_043 in the north-east), were so shallow and therefore so quickly dried-out that they offered very few clues to any considerations. All of them were rich in pottery finds (for the reasons explained above), BK2016_01_043 moreover, contained more mudbrick debris than the others, probably resulting from the collapse of BK2016_01_040 farther southeast.

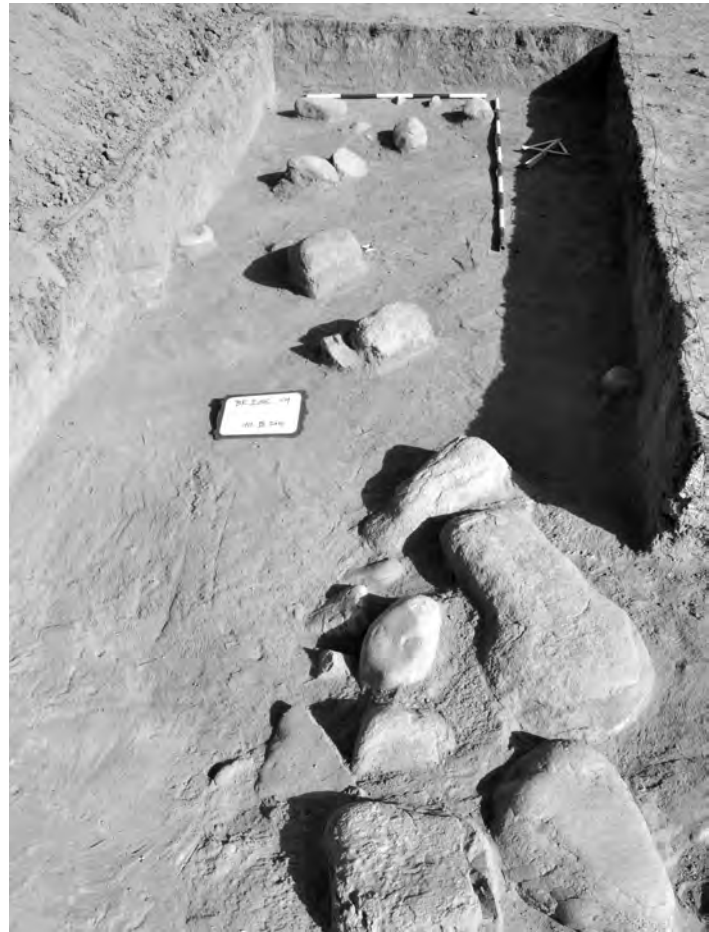
The line of stones in the direction SE–NW ends rather abruptly after a little more than one meter (**Fig. 3**) suggesting that this construction was either just a buttress intended to stabilize the main northeast-southwest wall or a part of a construction, only the southern part of which survived.

Fig. 3: BK01 - northwestern part of the trench excavated in 2016.
Photo J. Kysela.

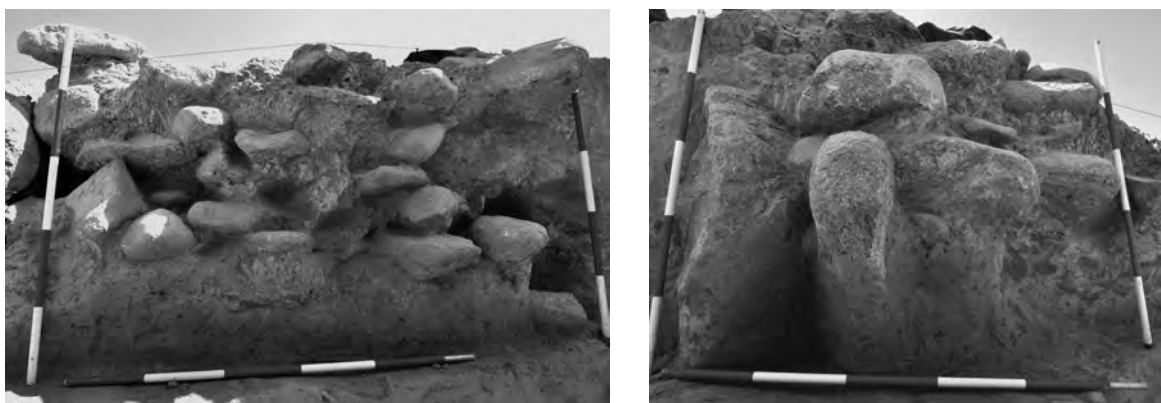
The two wall portions differed slightly in terms of their inner construction (**Fig. 4**). In the two-faced wall, the foundation was constituted by an orderly horizontal layer of mid-size pebbles (ca. 20–30 cm) packed in clay, while the base of the solid (boulder) wall was made up of big boulders (ca. 60 cm) often set vertically. This finding is of relative relevance because such vertically set big boulders were present also in the foundation of BK2016_06_002, i.e. a wall with two faces (see below). As mentioned above, we were not able to describe precisely the connection between these two wall portions; nevertheless, based on these discoveries we have no reason to doubt any more that they were basically created contemporarily and functioned as a single unit.

Fig. 4: BK07 – southwestern (left) and northeastern (right) section through the stone wall.
Photo J. Kysela.

The cut itself descended ca 1.6 m below the preserved top of the wall. The preserved height of the wall from this point to its foundations was 0.8–1 m. In neither of the wall portions have we identified any clues of a more complex construction history – the wall has a single phase and does not seem to have been preceded by another similar structure being built directly on the virgin soil.

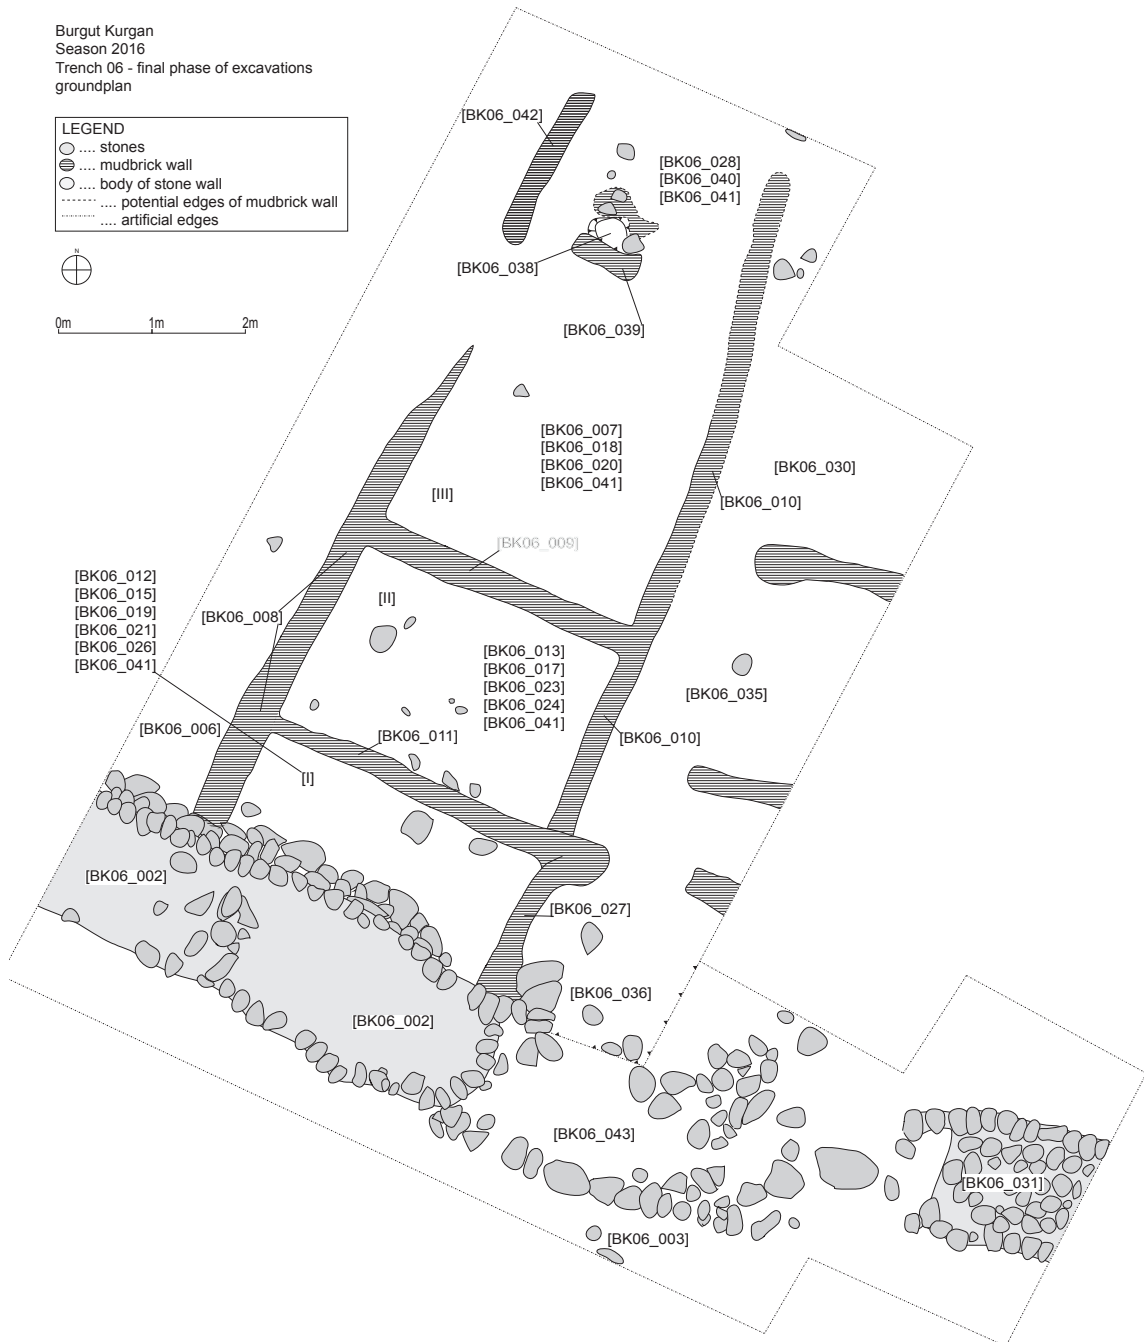
The excavation began with a trench of 4×8 m perpendicular to the stone wall and covering a narrow strip of land in front of the wall, the wall itself, and by the majority of its surface the settlement levels behind the wall. In order to follow the uncovered structures and to capture their complete plan, the original trench was later enlarged by 2 m to the southeast and by 3 m to the northeast, reaching the final dimensions of 11×6 m. Moreover, two other shallow trenches (3×2 m each) were then added to the south-eastern corner of the trench in order to trace the crown of the stone wall (**Fig. 5**).

Fig. 5: BK06. Overall plan of the 2016 excavation. Drawing by J. Havlík.

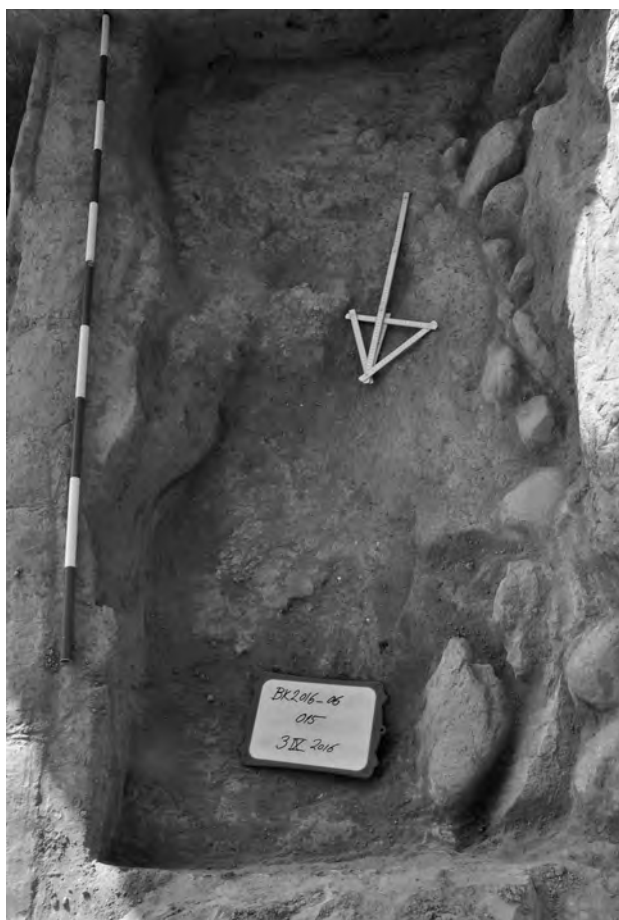
Fig. 6: BK06. The clay-coated floor BK2016_06_015 in room I. Photo J. Kysela.

Each of the destruction horizons rested directly on a floor and it was in contact with these floors that most of the finds were discovered. In the rooms I and II these floors (BK2016_06_015 in room I and BK2016_06_017 in room II) were clearly constructed with a fine clay coating. The situation was slightly different in room III where the transition between the burned layer BK2016_06_007 and the soft and clear BK2016_06_018 beneath it, was very gradual and all but clear-cut. The various thinner charcoal horizons were interlaid with layers of burnt earth, in several places the charcoal layer seemed to fill-in depressions in the ground. Still, it seems probable that these details do not reflect several events but rather taphonomic processes following a single conflagration. The circulation level in room III was indicated by several hard trodden spots but it does not seem to have been constructed as in the other two rooms.

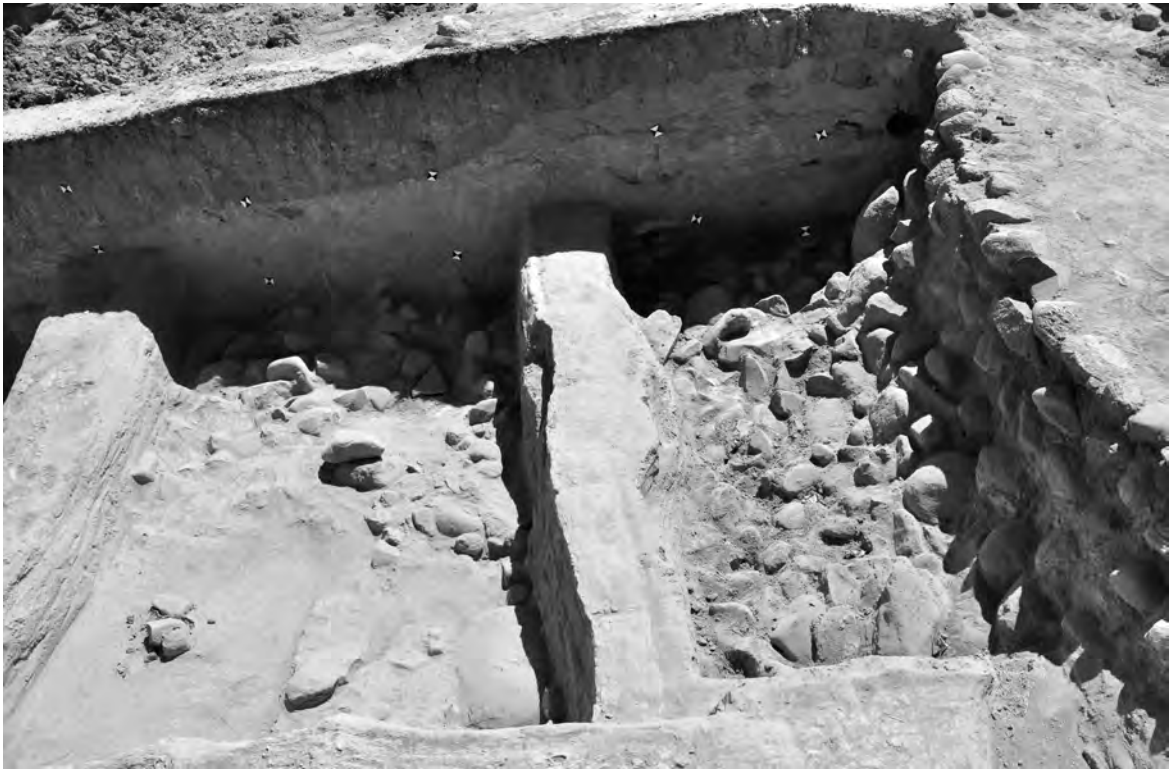
The difference between the floor of rooms I and II on the one hand and room III on the other hand is clear also from their substructure: while BK2016_06_018, i.e. the base of the floor in room III, is a naturally deposited level, in rooms I and II the clay coated floors rested upon thickly packed boulders consolidating the ground and levelling the slope into a veritable terrace (**Fig. 7**). Level of stones BK2016_06_021 covered by a sterile levelling loess layer BK2016_06_019 in room I; both of these components excavated as a single layer BK2016_06_023 in room II. The altitude difference between the highest point of room I and the lowest point of room II is ca. 30 cm but it decreases by a constant decrement. The two rooms were therefore not built on individual stepped terraces but rather on a continuous levelled platform ca. 3 m wide.

Fig. 7: BKo6. Stone terracing levels in rooms I and II. Photo J. Kysela.

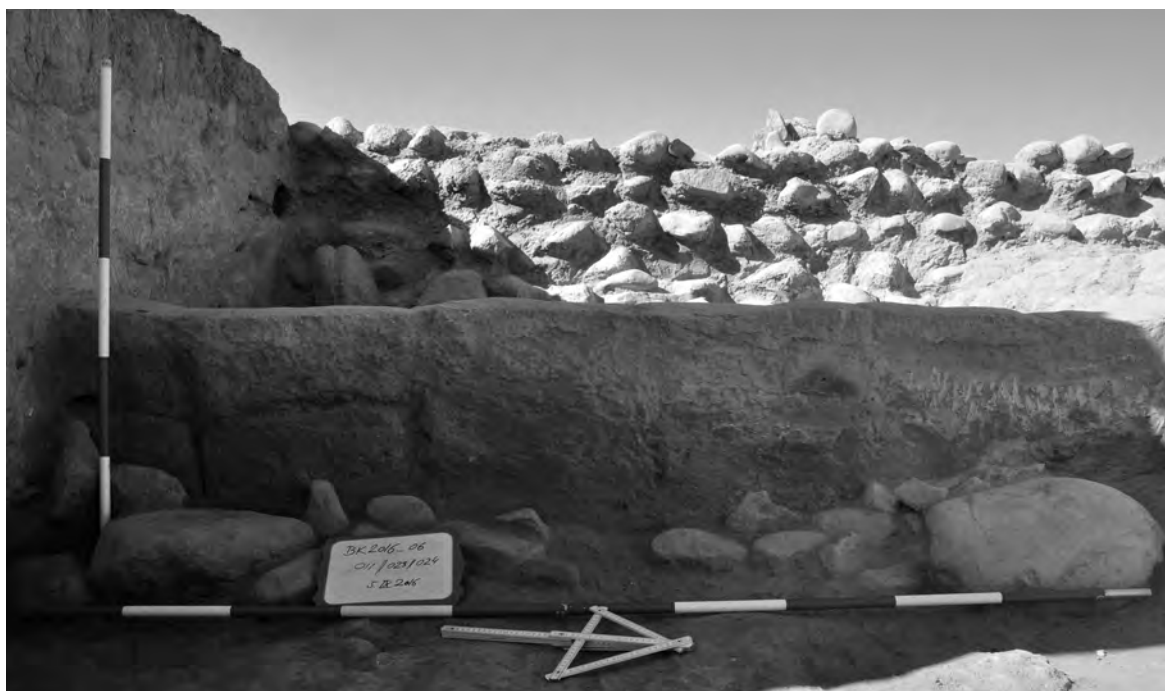
The mudbrick walls encircling and partitioning the rooms were all relatively light, all with the width of a single brick (thickness of ca. 20–30 cm). In the wall BK2016_06_011 we managed to distinguish very clearly the single bricks, in the other cases at least one or two brick contours per wall could be made out suggesting that all the walls were built of bricks of the same module (45×20–22×20–22 cm).¹ Curiously, the construction scheme of the wall BK2016_06_011 (**Fig. 8**) lacks any bond between the mudbricks which are simply put on top of each other with joints running continuously through the entire height of the wall. Unlike other constructions in the site, this wall brings little honour to its builder's skills and wit. The wall BK2016_06_027 is particular due to its arched shape.

Fig. 8: BK06. The mudbrick wall BK2016_06_011. Photo J. Kysela.

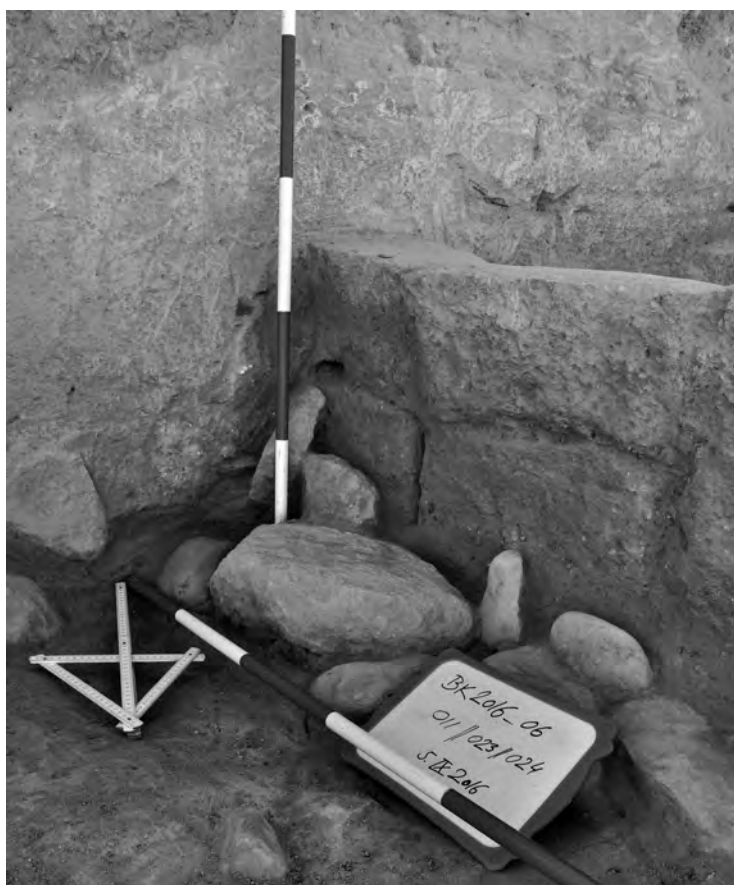
The relation between the levelling stone layer and the walls is most important but also curious: the construction of the stone layers in rooms I and II is clearly posterior to the construction of the wall BK2016_06_011 partitioning the two rooms (**Fig. 9**) and also to BK2016_06_009 between room II and III as well as the southeastern SW–NE walls BK2016_06_027 and _010. The walls stand directly on the ground while the stones creep up their foot. It should also be mentioned that the stones constituting the levelling layer in room I (BK2016_06_021) and those of the stone wall (BK2016_06_002) merge into a single unit. The contemporaneity of the levelling layers with the stone wall and their – immediate – posteriority (=contemporaneity) with the mudbrick partition walls suggest that these constructions came to be at a single moment and made part of a single project.

Fig. 9: BK06, room II: The stone terracing layer leaning against the wall BK2016_06_011. Photo J. Kysela.

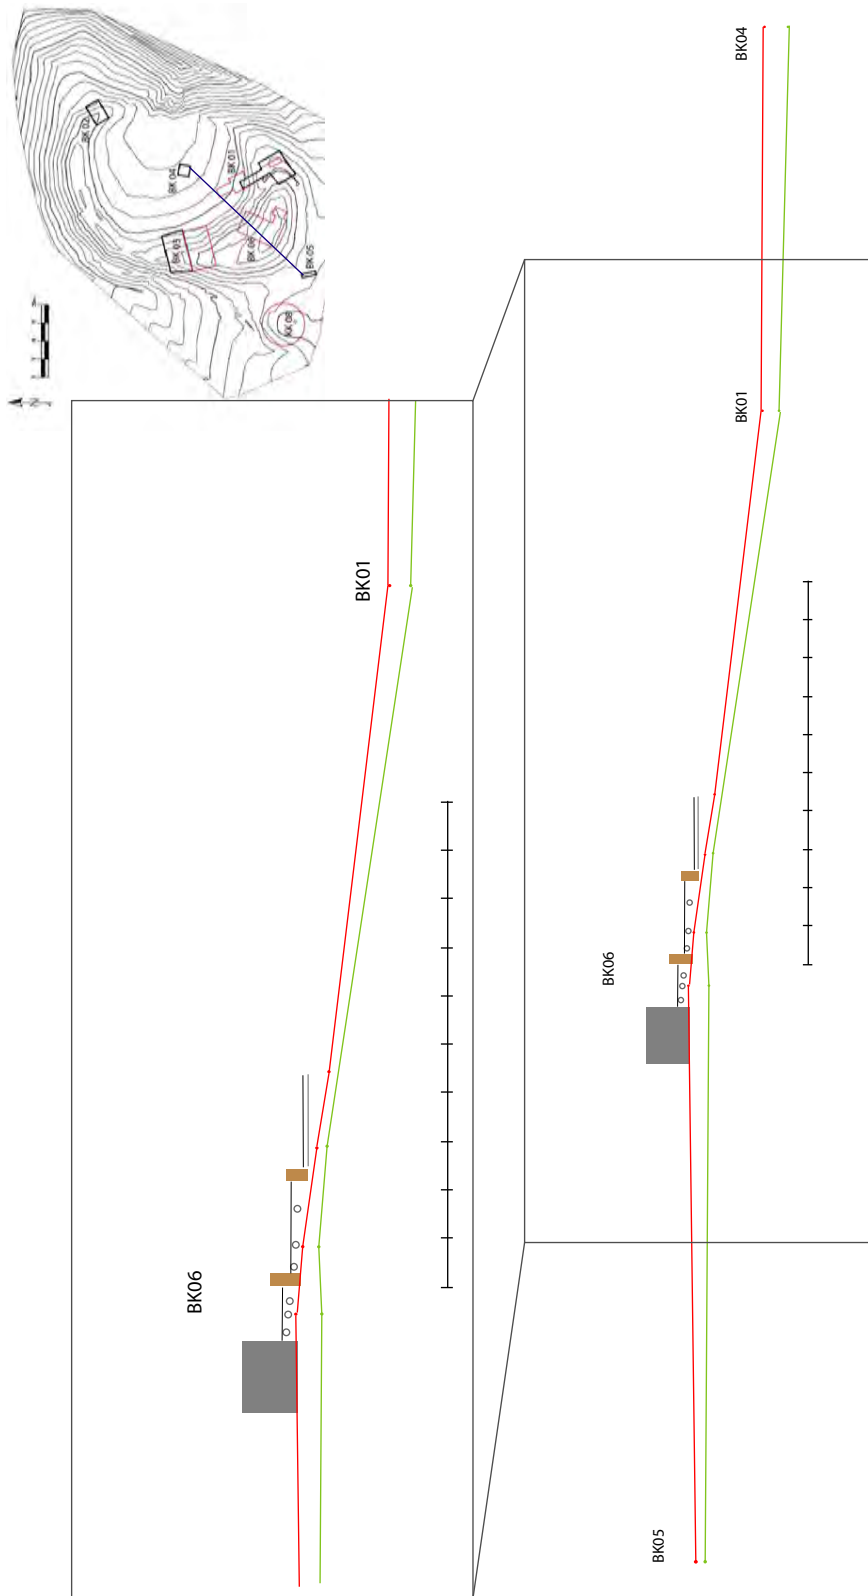
In all the three rooms small-scale trenches were cut in this layer in order to reach the level of the veritable virgin soil. Aligning their altitudes with the altitude of the virgin soil measured in other trenches (BK05 outside the settlement; BK06; the northern end of BK01; and BK04) we were able to reconstruct very preliminarily the original natural profile of the ground as well as (with less certitude) the terrain configuration at the moment when the stone wall was built (**Pl. 3/1**).

Pl. 3/1: Approximate reconstruction of the natural relief in the site of Burgut Kurgan. Green line - reconstructed level of virgin soil; red line - reconstructed level on which the Iron Age settlement was established. Drawing J. Kysela.
